IFH CONFERENCE OCTOBER 13-14, 2005, BERLIN

Musculoskeletal prevention for transmission & transport line workers

RWE⁽¹⁾

Institute for Biomechanics and Orthopaedics⁽²⁾

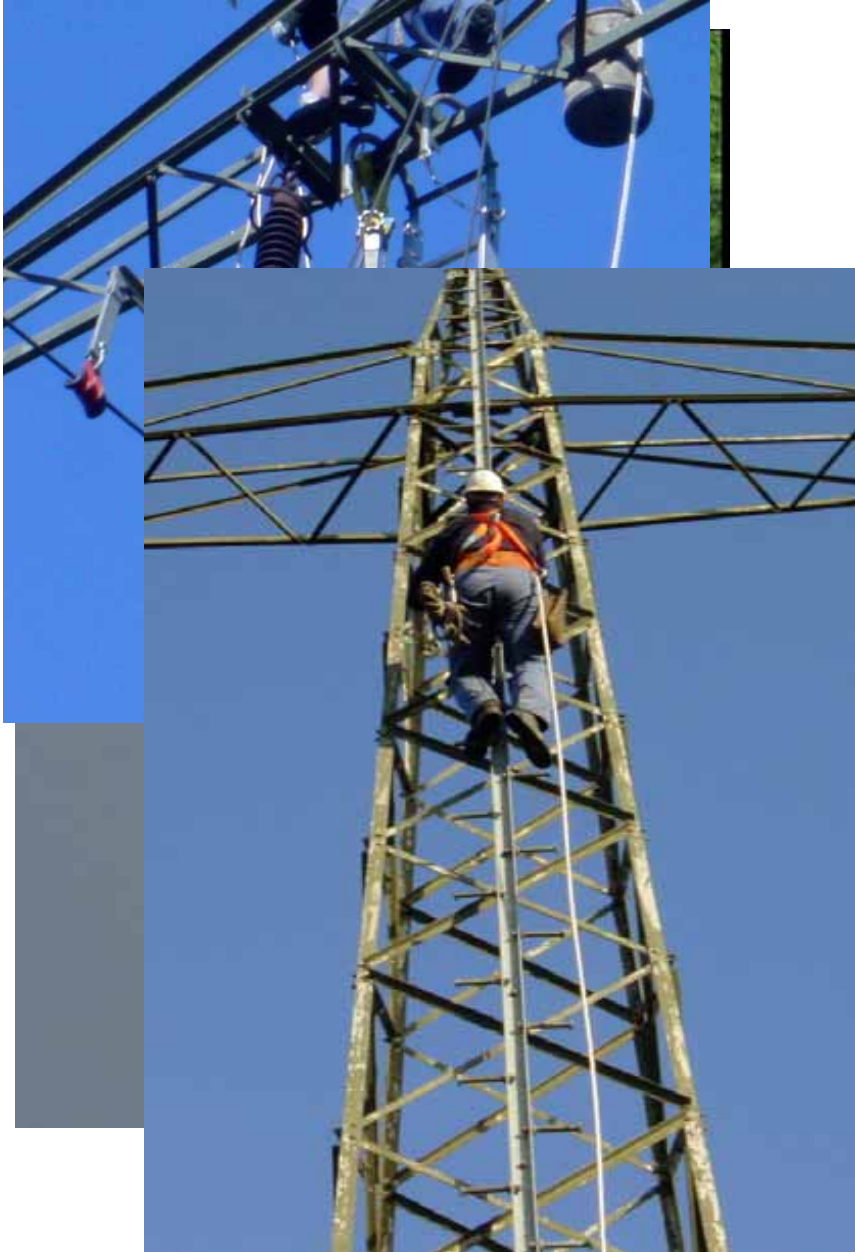
Transmission & transport line workers workplace

- risky
- dangerous to fall
- high voltage (>100 000 V)

- physical loading
- heavy external loads
- poor body positions
- unproper working positions
- climbing

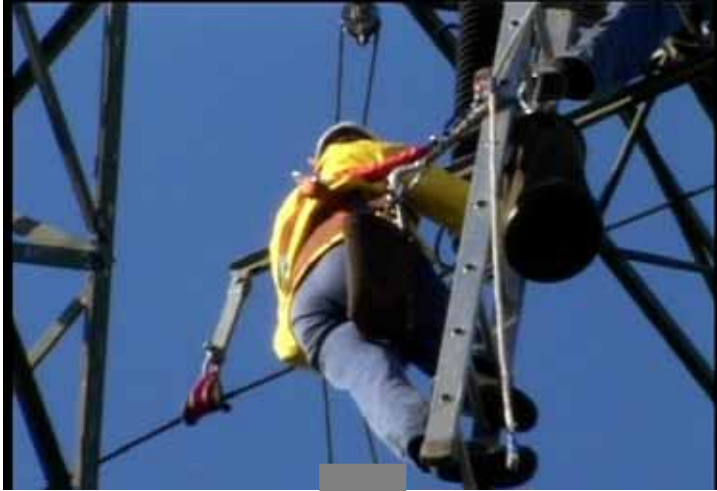
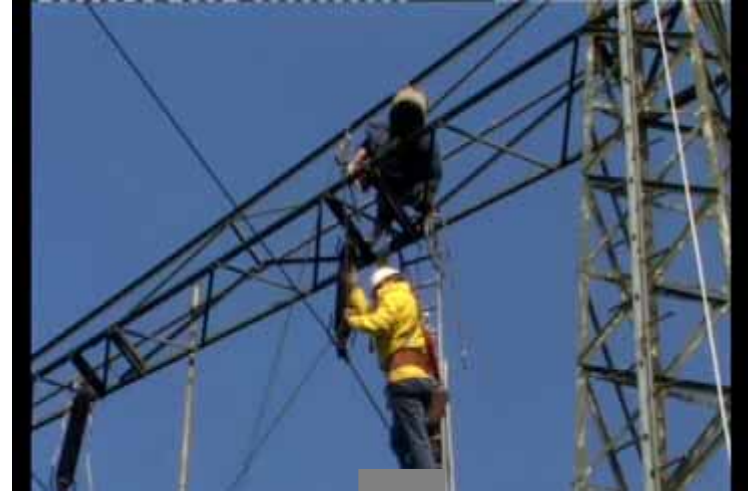
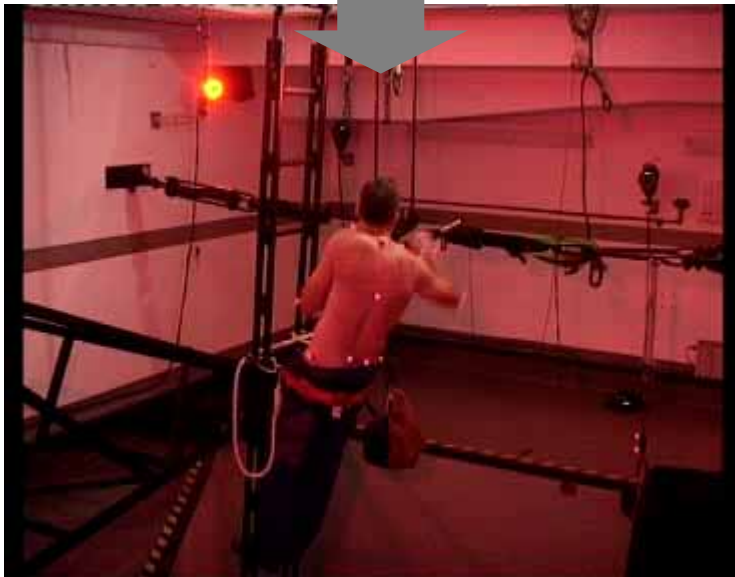
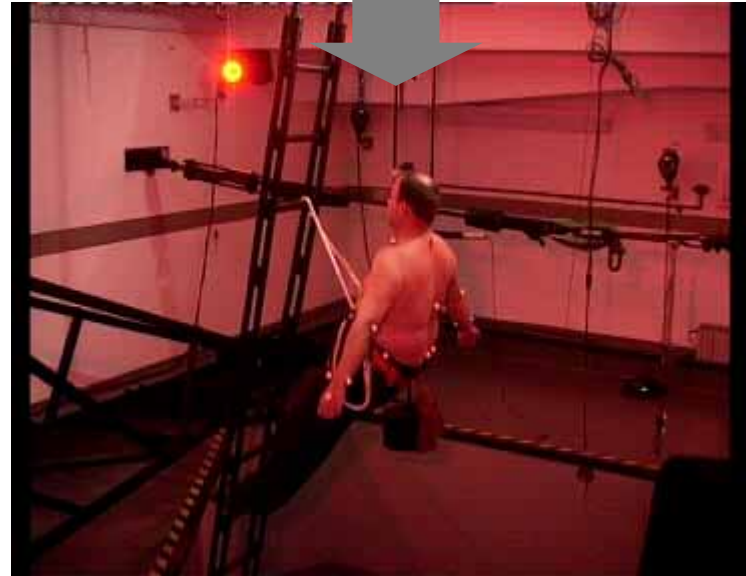
Biomechanics at the workplace

B: ladder, beam & traverse

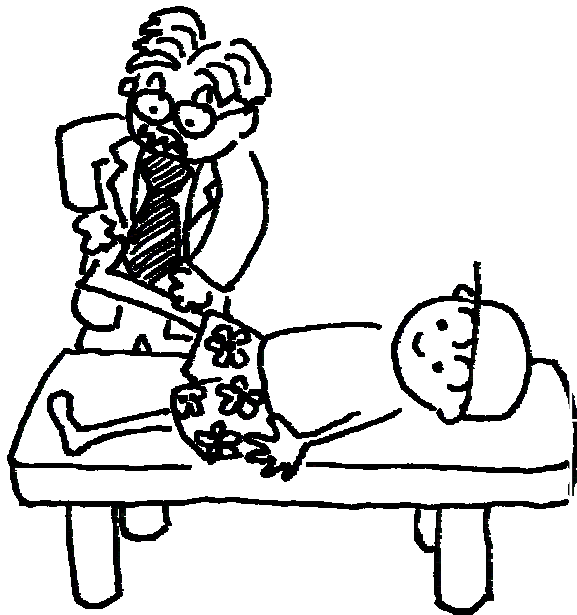
Clinical findings / worker

pre (03)	post (04)	Diff.
hip	2,3	0,8	-1,4
knee	1,8	0,5	-1,3
shoulder	1,9	0,9	-1,1
hand	0,5	0,2	-0,4
elbow	0,2	0,1	-0,1
trunk	1,7	1,7	0,0

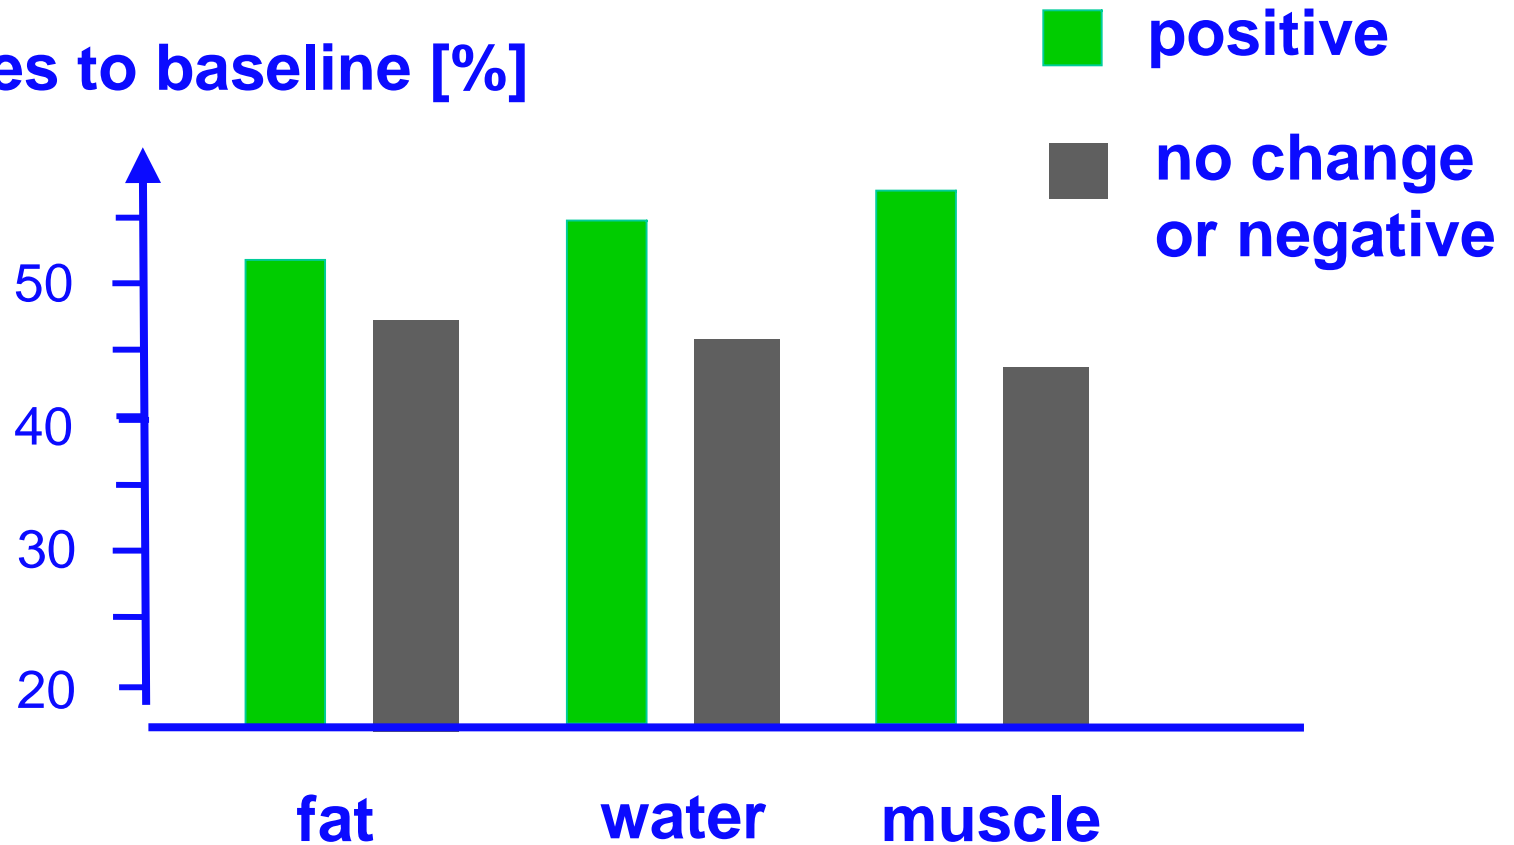
Body composition

Changes to baseline [%]

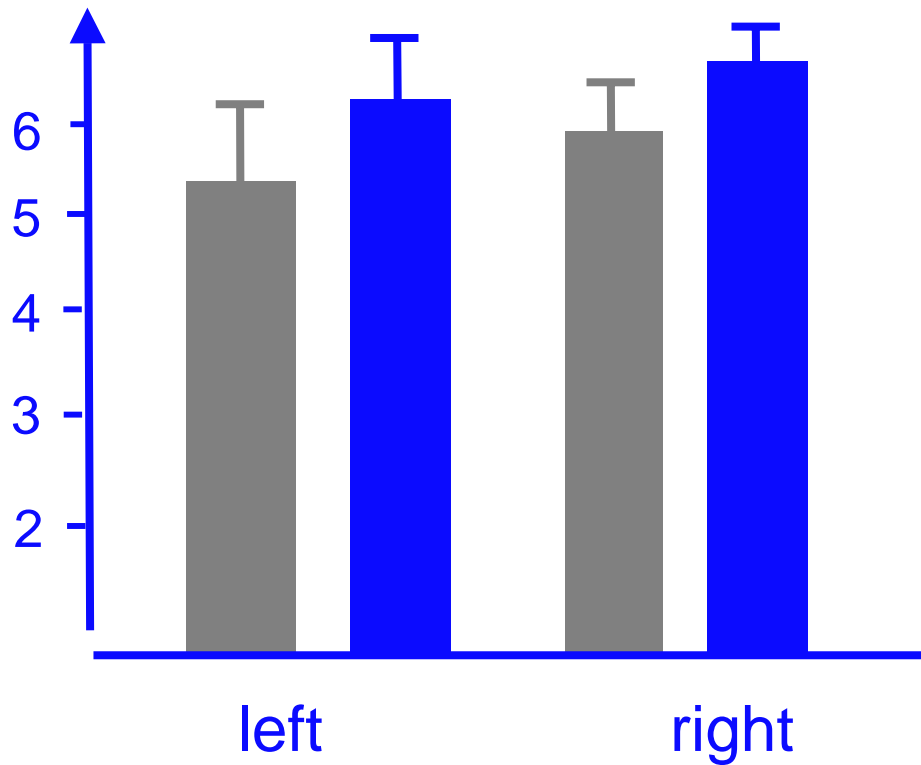
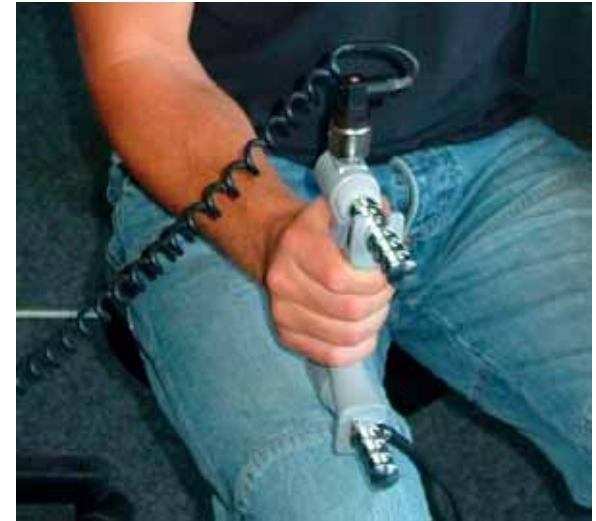
Grip strength [N/kg]

■ pre
■ post

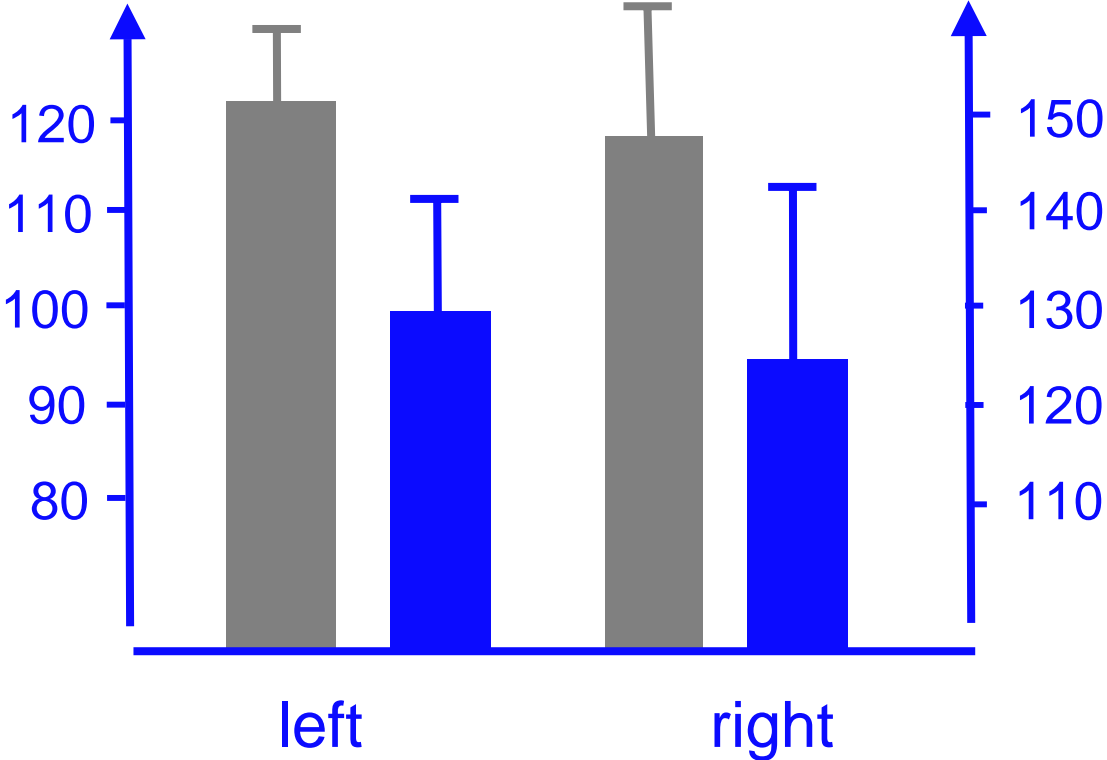
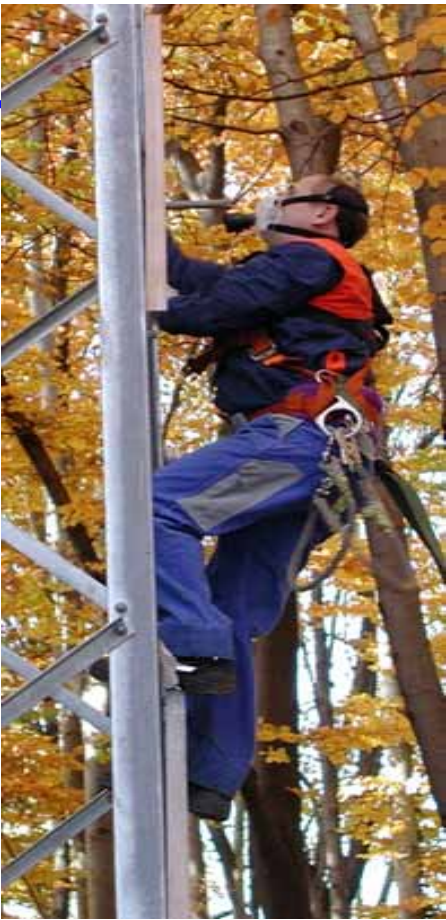
„Mast“-Ergometry

Heart rate [1/min]

VO₂ [ml/kg/min]

pre
post
